NASA Technical Memorandum 105430

Plasma Etching a Ceramic Composite

Prepared for the
24th Annual Convention of the International
Metallographic Society
Monterey, California, July 29–August 1, 1991

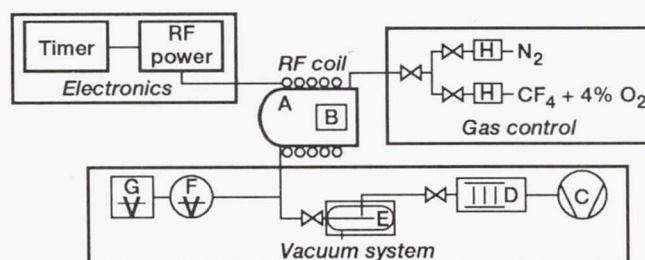
Figure 2.—Schematic diagram of plasma etching system. (a) Vacuum chamber. (b) Specimen. (c) Mechanical vacuum pump (fomblin oil). (d) Sorption trap. (e) Liquid nitrogen trap. (f) Thermocouple gauge. (g) Vacuum read out. (h) Flow meter.

Etching of the specimens was performed by two methods; molten salt or plasma etching. Etching with molten KOH was performed as outlined in figure 1. The specimen was removed from the epoxy mount, wrapped in platinum wire and immersed in molten KOH at 673 K for 10 to 15 sec. Plasma etching was performed using the system shown in figure 2. The mounted sample is placed in the vacuum chamber and evacuated to 0.1 torr. The sample is preheated using nitrogen at 0.2 torr and plasma RF power of 100 W for 10 min. Next, etching is performed using $\text{CF}_4+4\%\text{O}_2$ at 0.3 torr and plasma RF power of 100 W for 2 to 5 min.

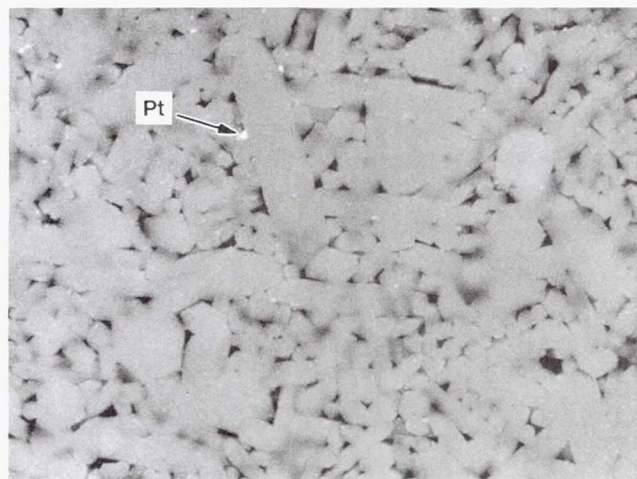
(a) Etched 10 seconds.

Figure 4.—Back scattered electron images of $\text{SiC}_w/\text{Si}_3\text{N}_4$ composite following molten KOH etching at 673 K.

Molten salt etching removes the intergranular glass leaving the SiC_w and Si_3N_4 grains in relief (fig. 4). Back scattered electron imaging again can not differentiate SiC_w from Si_3N_4 . The white particles were identified by XEDS as contamination from the platinum crucible during etching. Obtaining reproducible etching results is difficult as shown by the influence an additional 5 sec had on the depth of etching on a second specimen (fig. 4(b)).

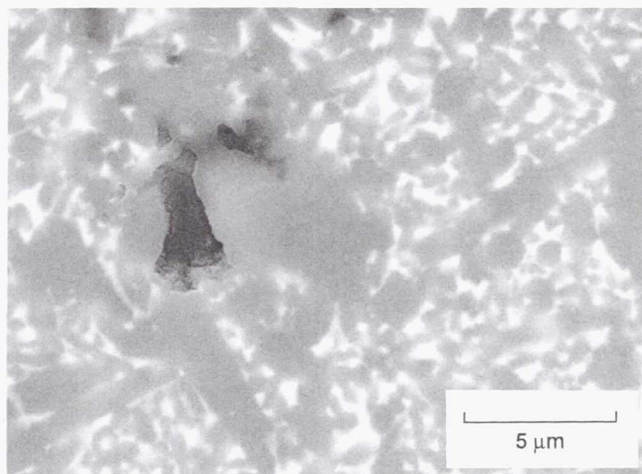
Figure 3.—Back scattered electron image of as-polished $\text{SiC}_w/\text{Si}_3\text{N}_4$ matrix composite.

Back scattered electron imaging of the as-polished composite allows the identification of three microstructural features (fig. 3). The white phase is the CeO_2 rich glass phase as determined by x-ray energy dispersive spectroscopy (XEDS), the black areas are regions of porosity, and the gray phase is SiC_w or Si_3N_4 . Measurement of the size and shape of the gray phase is possible, but SiC_w and Si_3N_4 can not be differentiated due to their identical average atomic number ($\text{SiC}:(14+6)/2=10$; $\text{Si}_3\text{N}_4:(3*14+4*7)/7=10$).

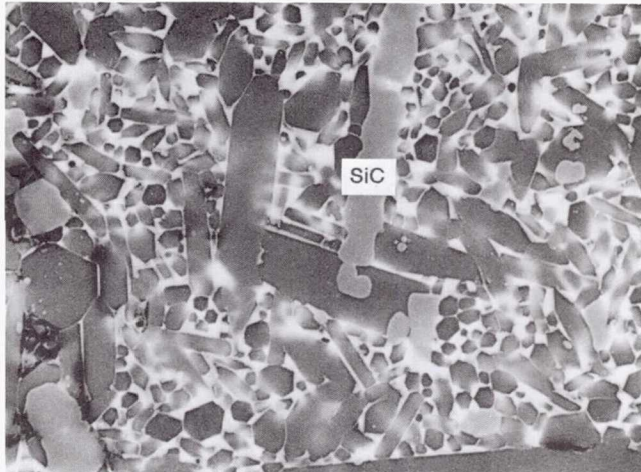
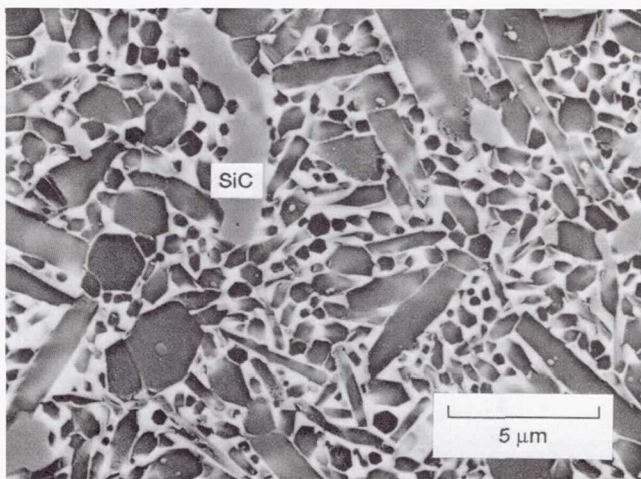
Figure 5.—Back scattered electron images of plasma etched $\text{SiC}_w/\text{Si}_3\text{N}_4$ composite (10 minutes N_2 preheat and $\text{CF}_4 + 4\% \text{O}_2$ etch for times shown).

Plasma etching selectively attacks the Si_3N_4 leaving the SiC_w and glass in relief (fig. 5). Back scattered electron imaging reveals the CeO_2 rich glass as the white phase. An atomic number difference between Si_3N_4 and SiC_w is observed, with the SiC_w being lighter, and thus, apparently higher in average atomic number. As etching time is increased to 5 min, the contrast between SiC_w and Si_3N_4 increases (fig. 5(b)). Examination of the specimen surfaces at higher magnification, using secondary electrons, reveals a mottled structure on the Si_3N_4 , with the SiC_w and glass appearing unaffected (fig. 6). The longer etching time (5 min) removed more of the Si_3N_4 .

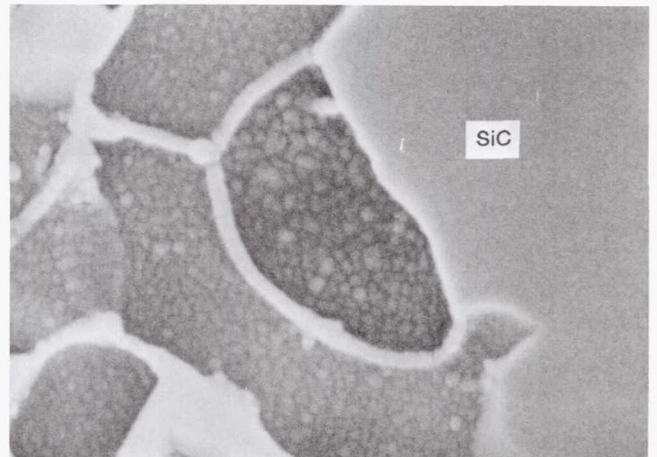
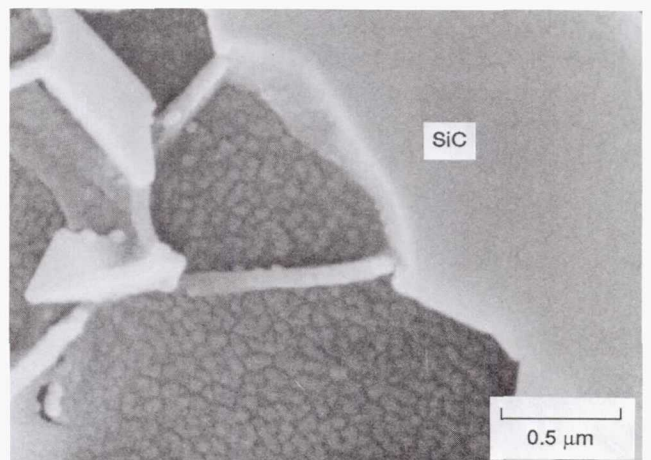
Figure 6.—High magnification secondary electron micrographs after plasma etching.

The apparent atomic number difference between SiC_w and Si_3N_4 is explained by the deposition of carbon during removal of Si_3N_4 , as identified by TEM (fig. 7). A schematic drawing of a cross section of the composite surface is shown in figure 9. Although the chemical reactions that occur in the plasma etching process are not fully understood (refs. 6 and 7), the chemical reaction shown in equation (1) provides a basic understanding of the source for the carbon. Fragments of CF_x , generated by the $\text{CF}_4+4\%\text{O}_2$ plasma, react with Si_3N_4 to form volatile products of SiF_y and N_2 which are removed by the vacuum pump, while carbon is deposited on the Si_3N_4 . For the etching to proceed the carbon must be removed by reaction with the $4\%\text{O}_2$ to form CO and/or CO_2 (eq. (2)). The selective carbon deposition provided by the chemical reaction at the Si_3N_4 surface provides a decrease in the apparent average atomic number of the Si_3N_4 , while the SiC_w surface remains unetched (fig. 6).

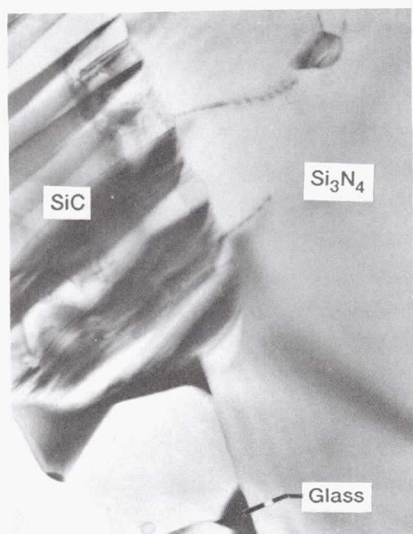
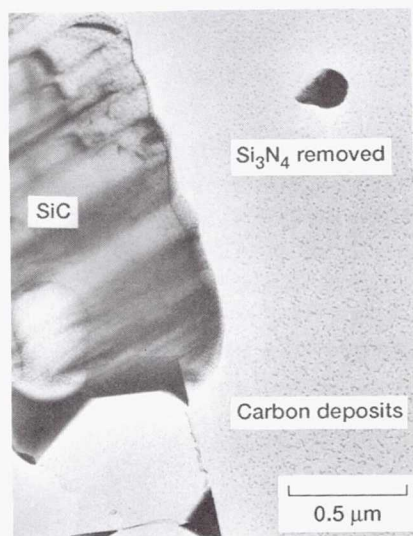
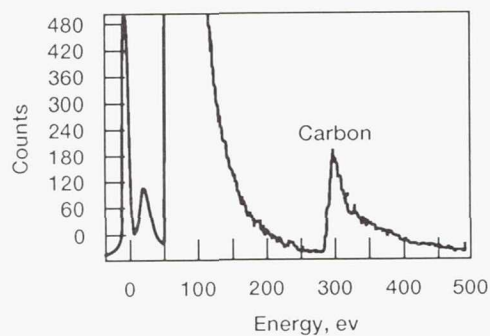
(a) As prepared.

(b) After plasma etching 2 minutes.

(c) Electron energy loss spectrum of deposits.

Figure 7.—TEM bright field of SiC_w/Si₃N₄ matrix composite.

TEM of an as prepared specimen shows the typical faulted structure of the SiC_w , an intergranular glass phase, and Si_3N_4 grains containing dislocations (fig. 7(a)). After plasma etching for 2 min, examination of the exact same region shows the SiC_w and glass are intact, but the Si_3N_4 is removed as evidenced by the absence of the dislocations (fig. 7(b)). The evaporated conductive carbon film is intact with a mottled deposit on it. Electron diffraction of the deposit showed an amorphous pattern and EELS shows carbon as the only element present (fig. 7(c)).

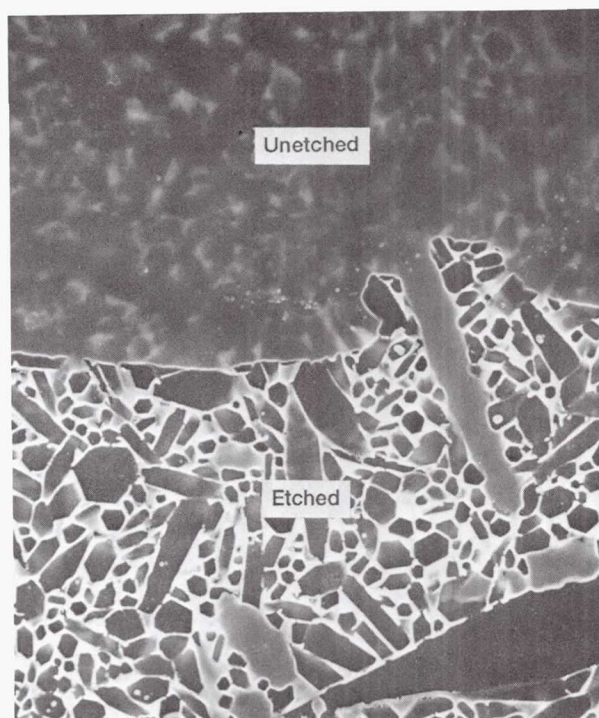
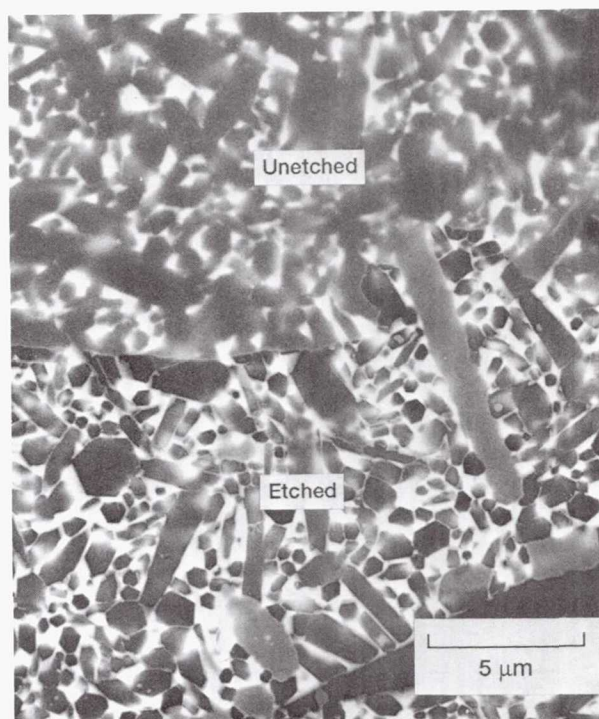
(a) Secondary electrons.

(b) Back scattered electrons.

Figure 8.—Partial etching of SiC_w/Si₃N₄ matrix composite.

Plasma etching overcomes all of the problems discussed above. The temperature of the sample during plasma etching remains less than 358 K, using the etching conditions discussed. The epoxy mount can withstand temperatures to approximately 423 K, therefore the sample can remain in the mount. Another benefit of the lower etching temperature is the ability to partially etch a sample by simply covering a portion with adhesive tape (fig. 8). This is very useful for samples that might require unetched areas for electron microprobe studies.

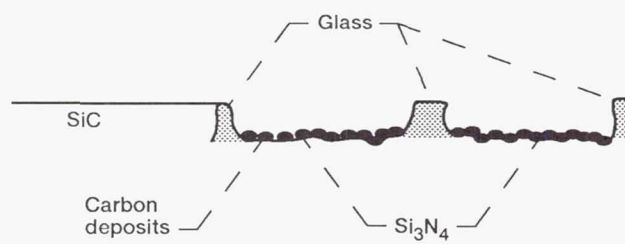
Figure 9.—Schematic cross-section of composite after plasma etching.
